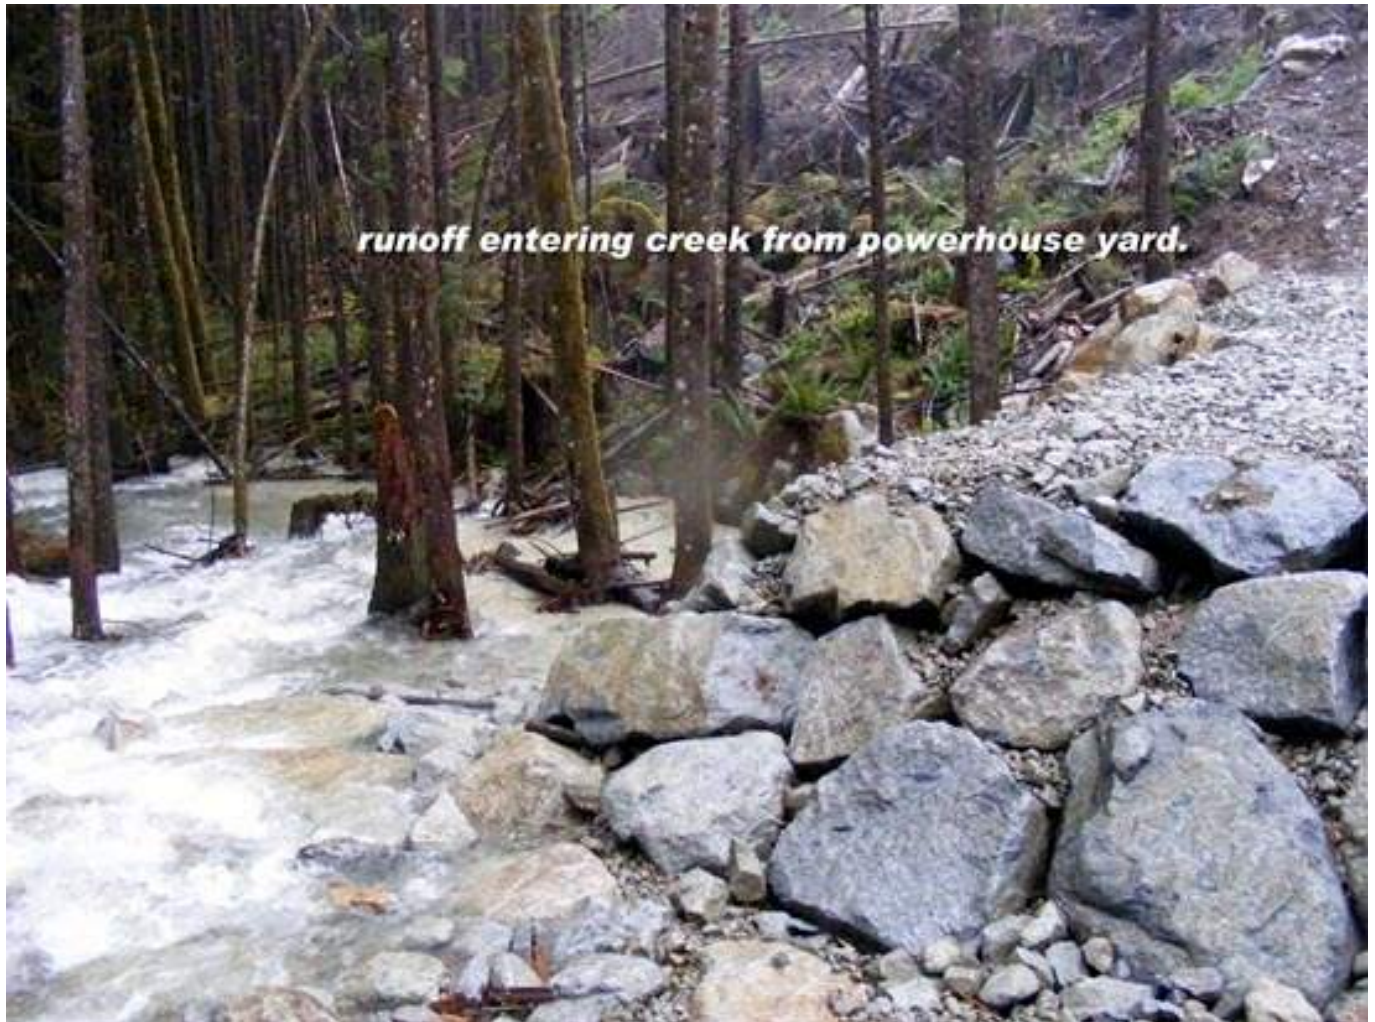
Corner of the raceway as it enters Tyson Creek. The creek splits into two arms at this point. The right arm (in view) is fish bearing. The silty water (center left) in the photo is from the runoff collected behind the powerhouse (as previously noted, corrective action has been taken).
