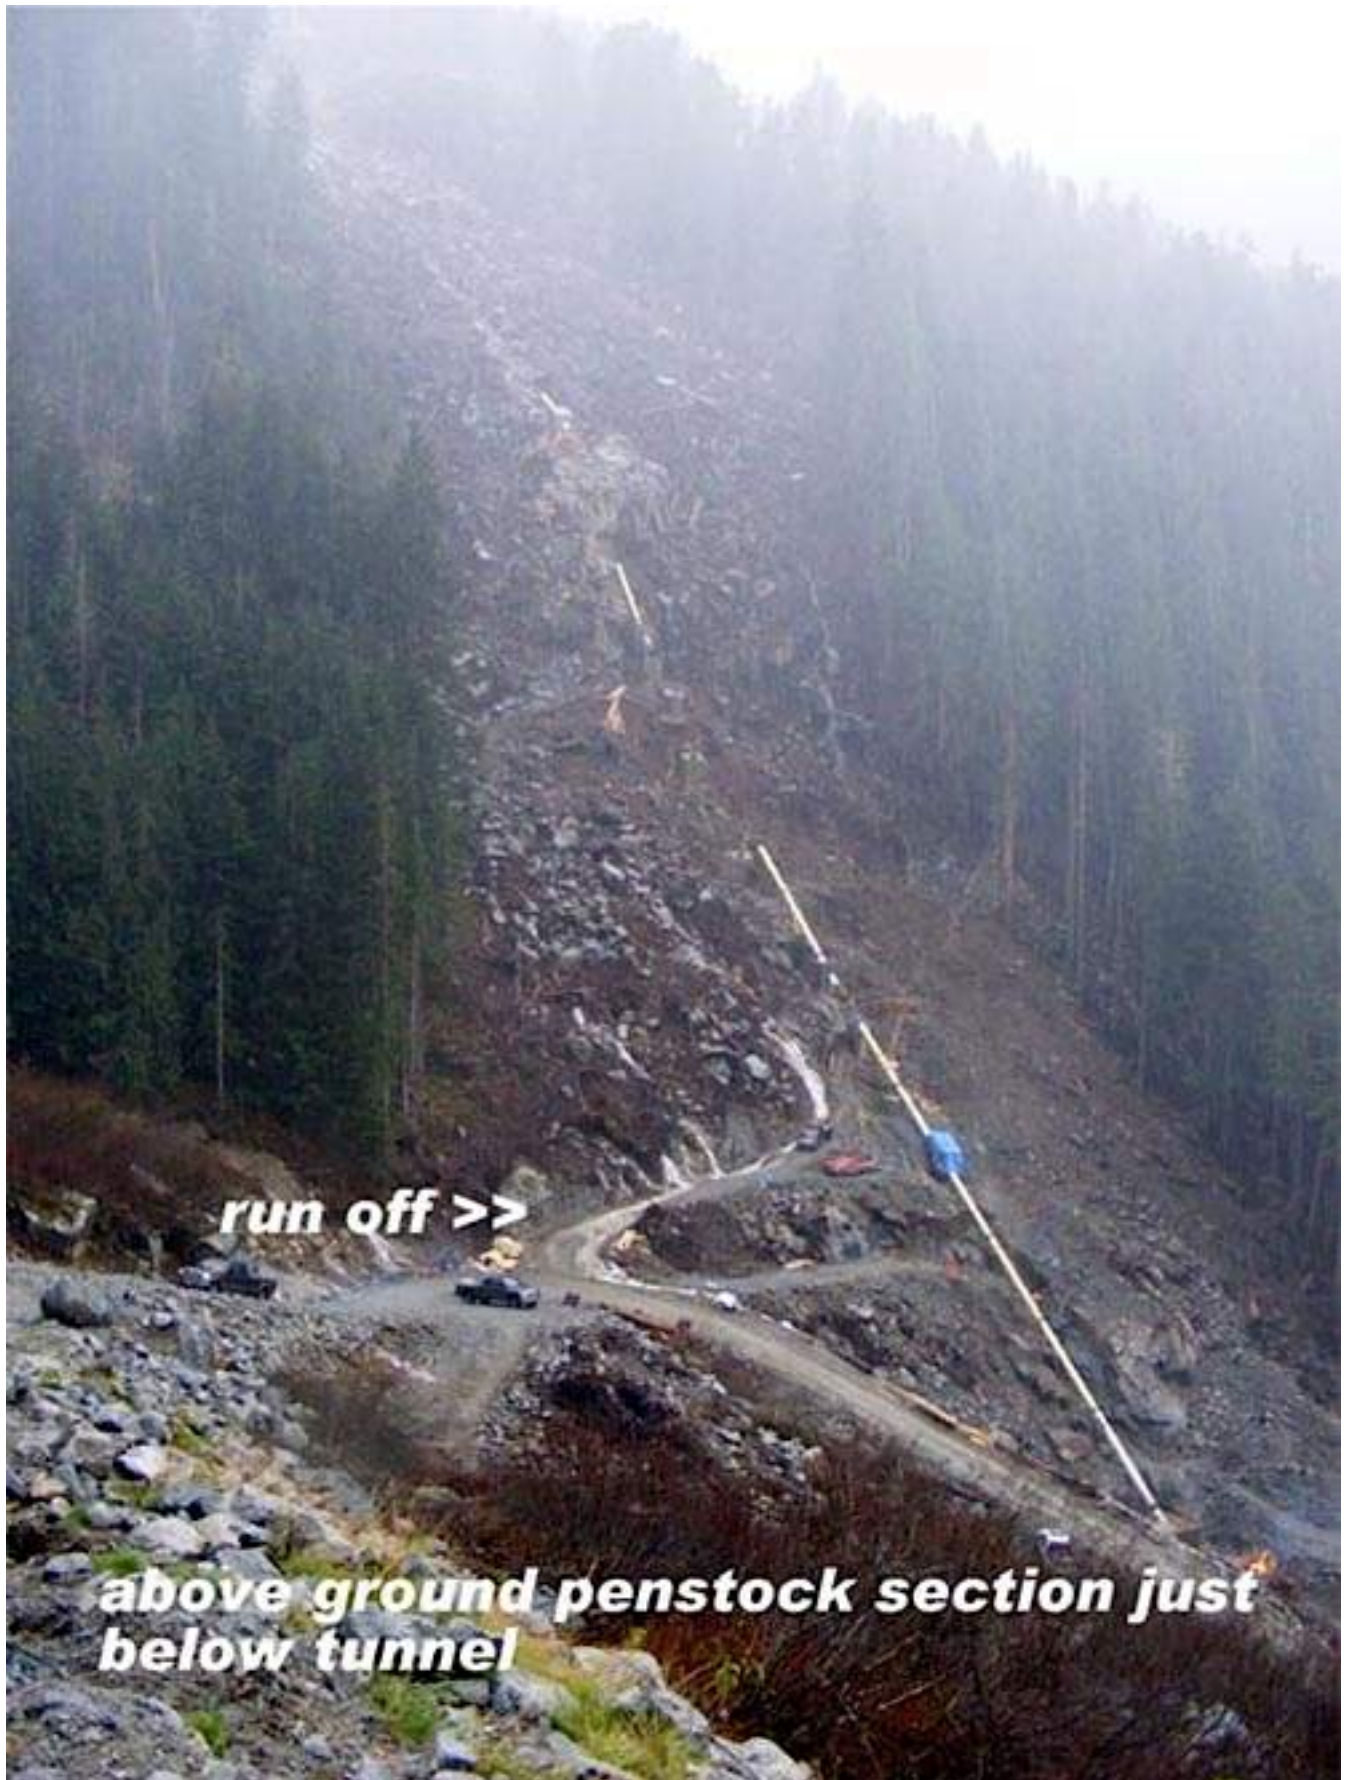
This photo shows the section of penstock that will remain above ground. The tunnel entrance is not in the picture but is located above the upper left corner of the photo. A significant volume of runoff water can be seen rushing along the curve of the road then heading down to the next landing and over a road bank. There were no ditching or containment efforts evident at the time of photo. According to company personnel, corrective measures have been taken.
