Penstock down to Tyson Powerhouse

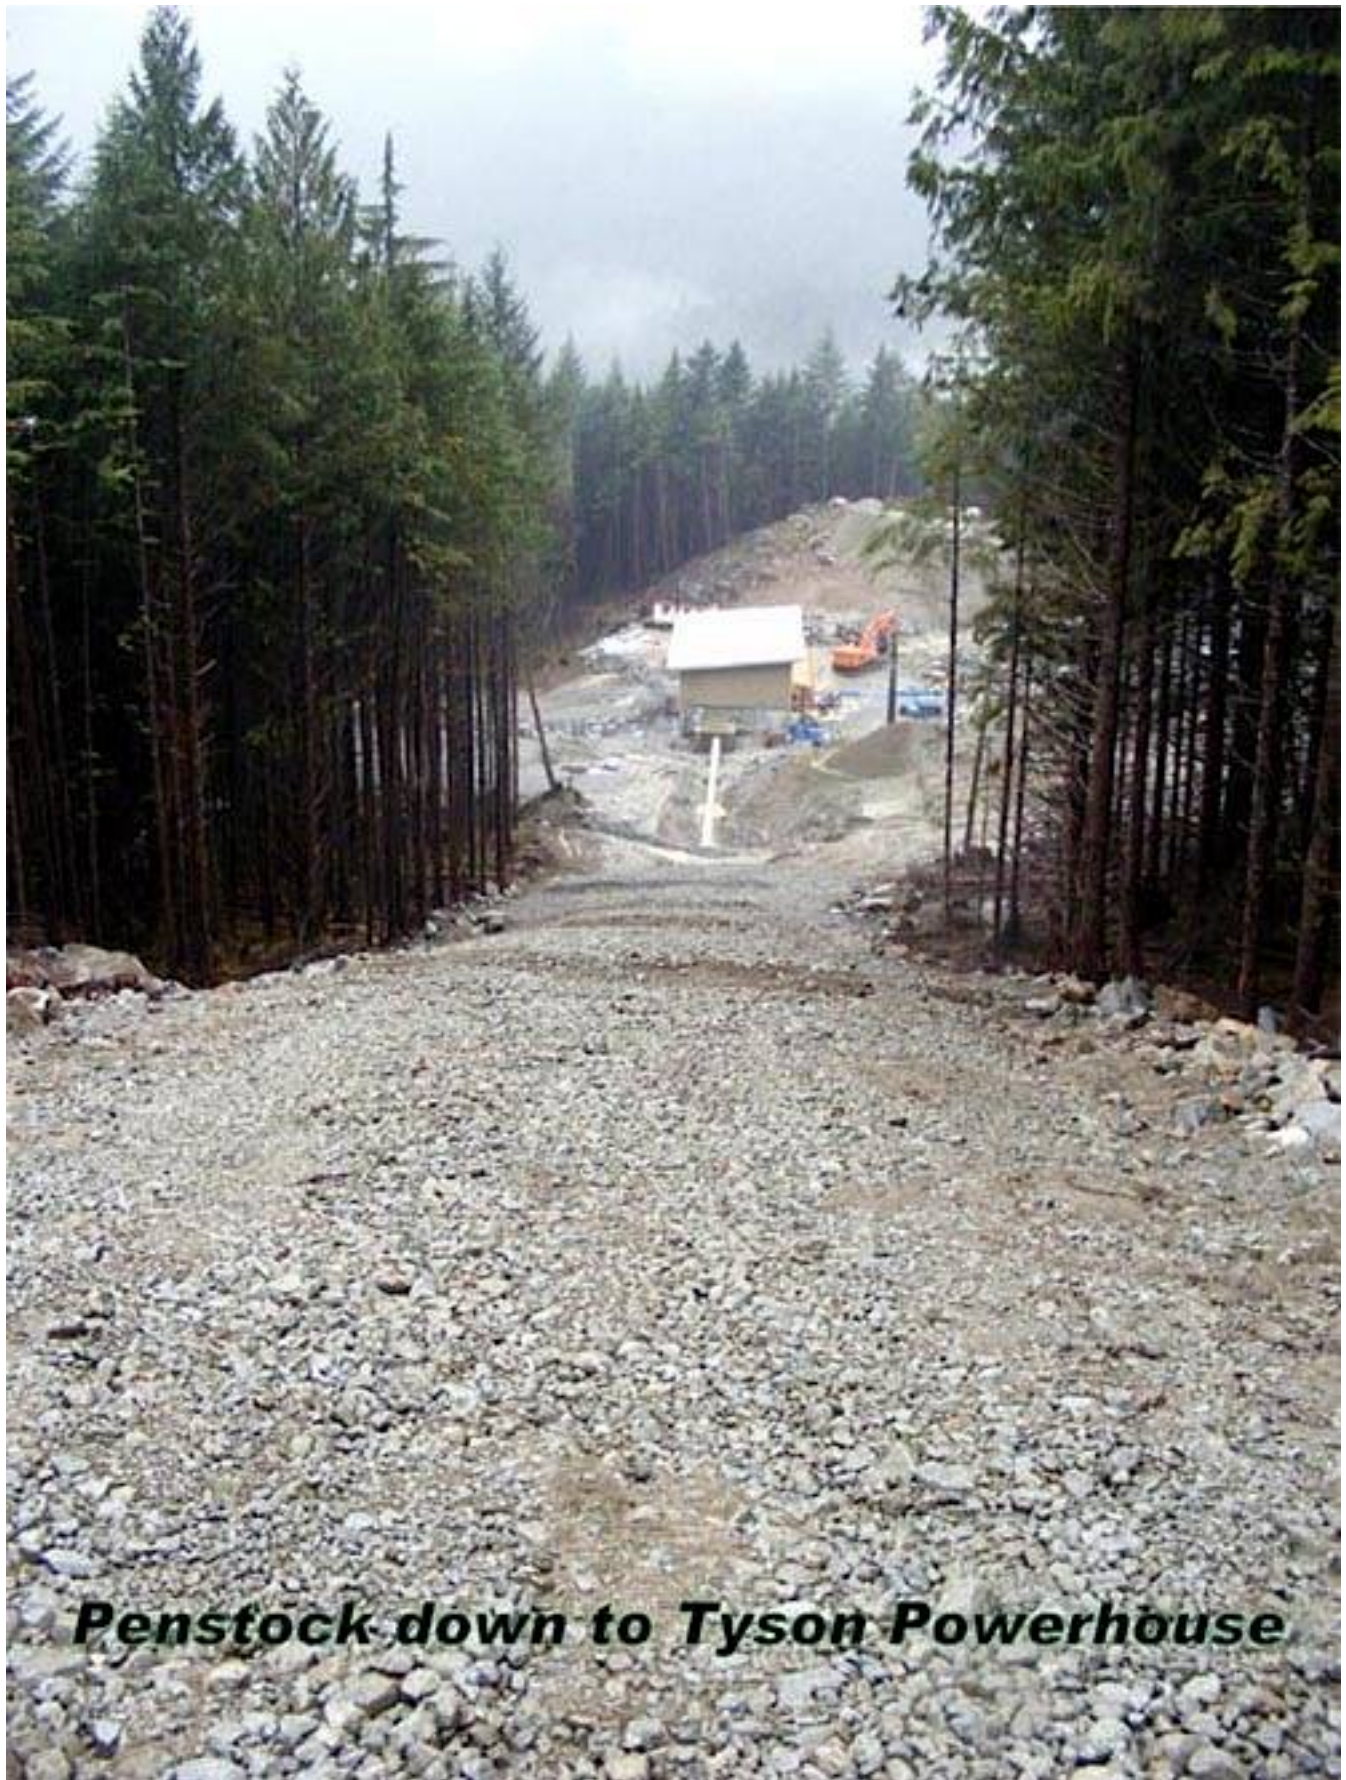
Looking down along buried penstock to the powerhouse, there is significant potential for erosion. This increases dramatically if any traffic is permitted on the slope. A ditch and a small settling pond were built at the base of this slope, which is immediately adjacent to Tyson Creek.
